UNITED STATES ENVIRONMENTAL PROTECTION AGENCY
REGION IX
75 Hawthorne Street
San Francisco, CA 94105-3901

Purpose: RCRA Compliance Evaluation Inspection

Facility Name: Cal-Tron Plating, Inc.

Date of Investigation: November 4, 2003

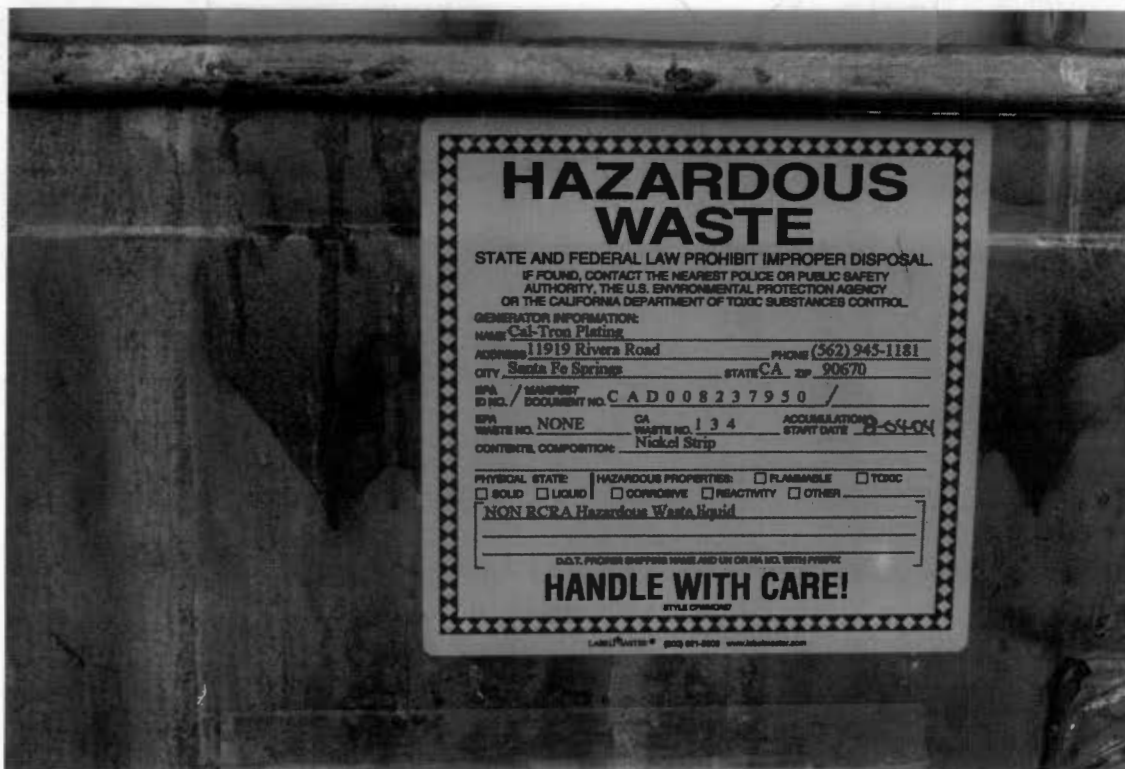
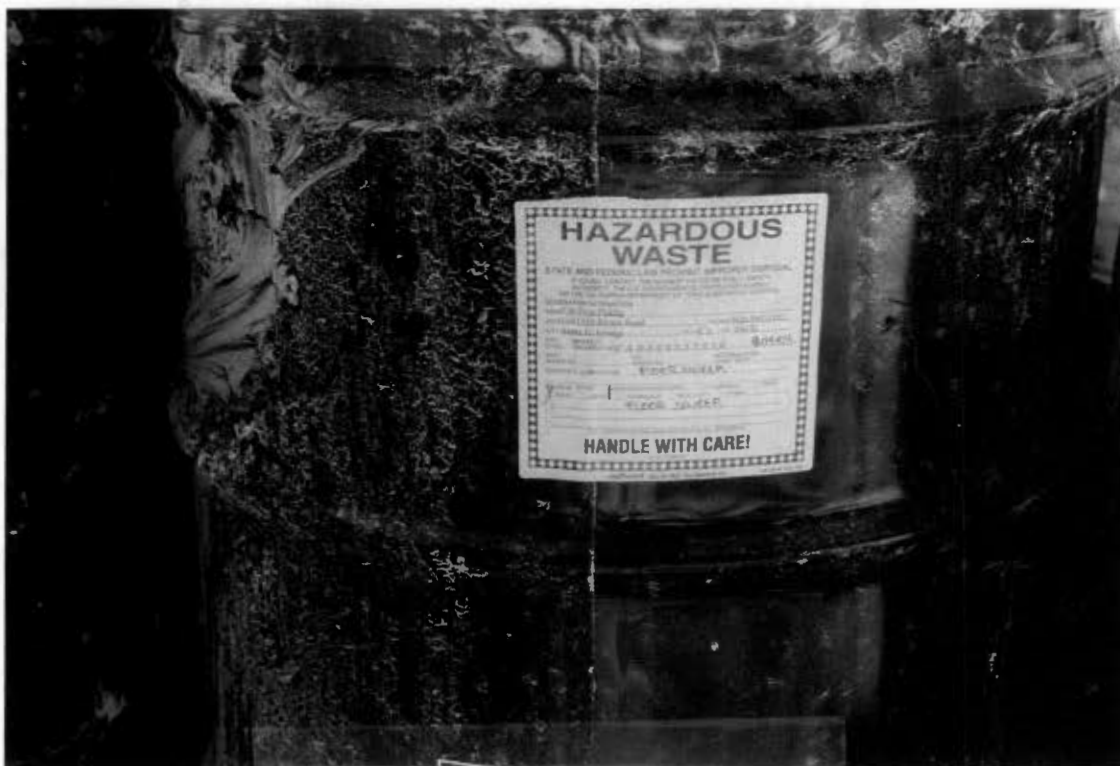
**HAZARDOUS WASTE LABEL
SHOWING ACCUMULATION START DATE**

6. All hazardous waste is being removed from the facility within the 90 day time period that a large quantity generator is allowed. Please review the photographs of the hazardous waste labels that we have submitted with this letter.

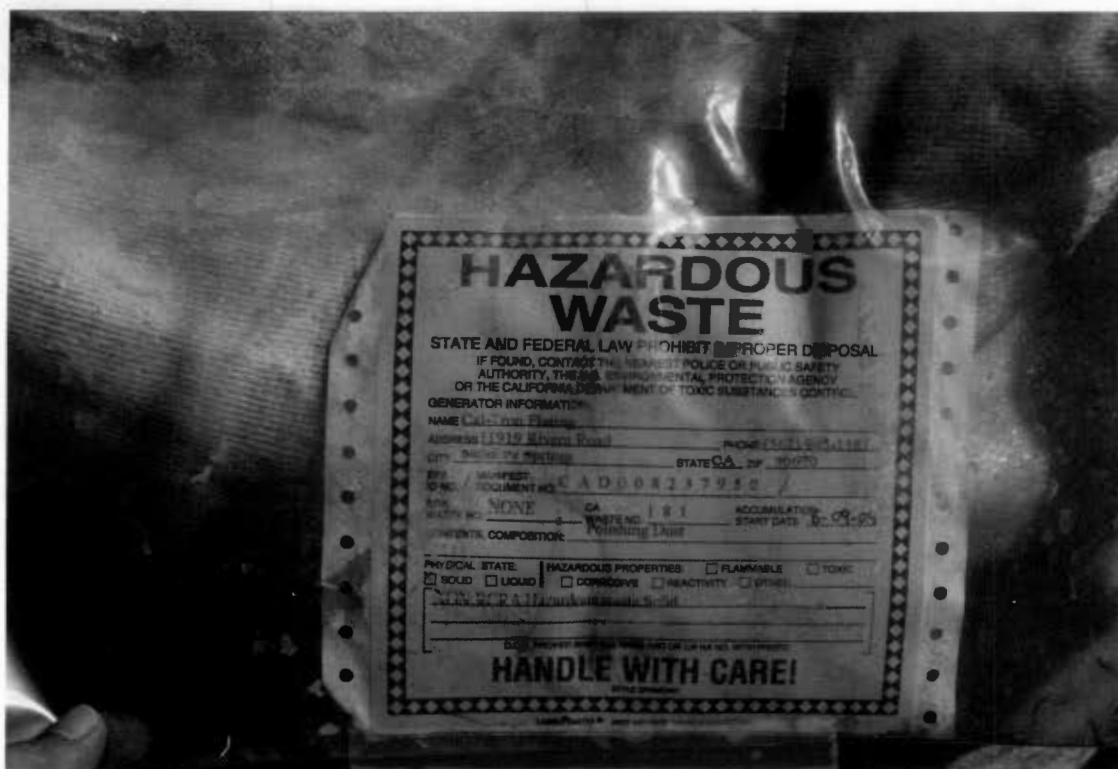
**HAZARDOUS WASTE LABEL
SHOWING ACCUMULATION START DATE**

3. All hazardous waste containers are properly labeled, and we have included photographs of typical container labels for you to review.
4. Polishing dust is continually being generated at our facility. It is the policy of the facility to repair the vacuum system when it is observed to be broken.

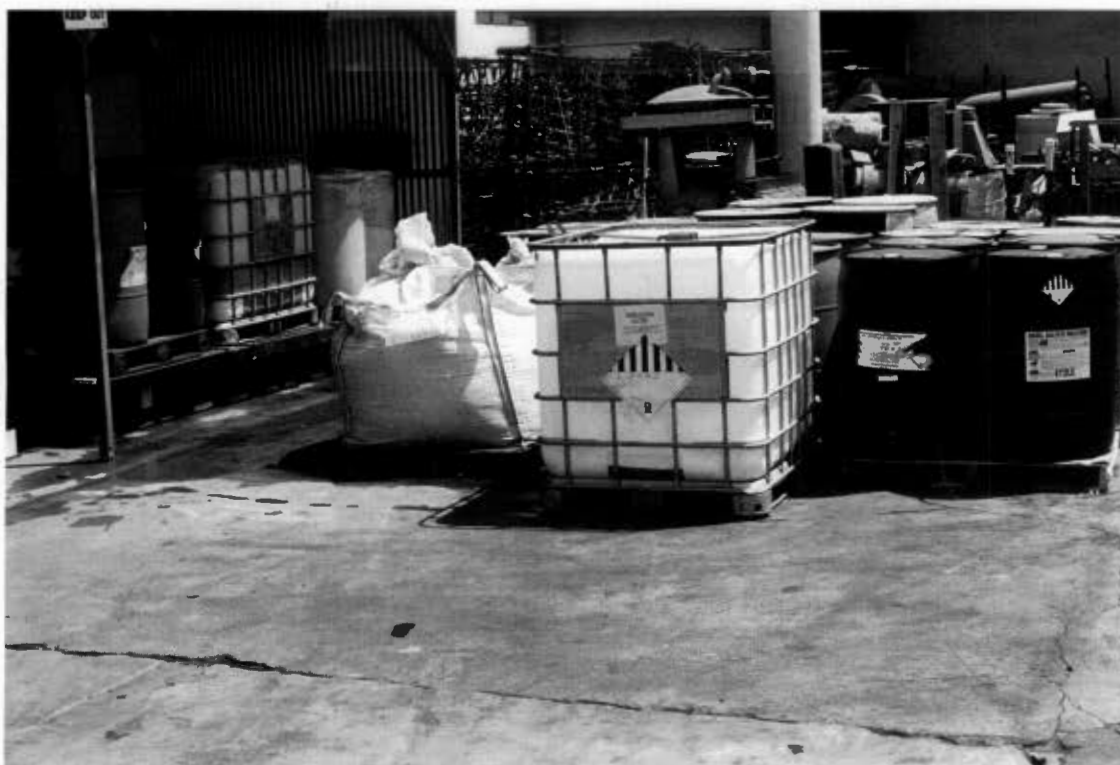
**HAZARDOUS WASTE STORAGE
SHOWING SPACE BETWEEN ISLES**

5. Aisle space between the hazardous waste storage area and the material storage shed is being maintained. We have included photographs demonstrating this with this letter.
